A Survey of Historic Buildings in Sivrihisar Using Advanced Technologies

3. Case Study: Survey of Historic Buildings in Sivrihisar

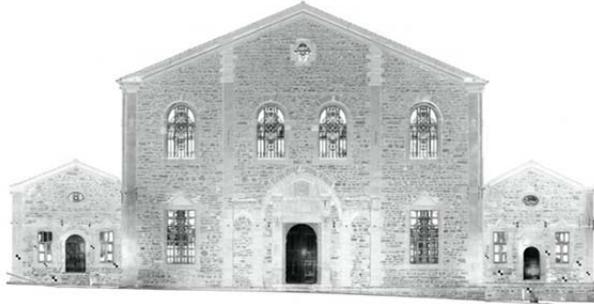
Figure 5. Facades produced by 3D laser scanning model

For each scanning position read by the 3D Laser Scanning device, reading errors, connection errors to the project coordinate system, unreadable areas (blind spots) in the scanning area are detected and the found errors are corrected (Figure 3). Unreadable areas are completed in the next positions. After all the measurement work is completed, the data checked in the field are cleaned, colored, and poly-data and orthopoints (Figure 4 and Figure 5) are created with the help of high-capacity computers.
