# Assessing the State of Preservation After Adaptive Reuse: Three Historic Madrasas in Istanbul-A Case Study

**Abstract** – Heritage buildings serve as witnesses to our past and the keeper of our shared values. While adaptive reuse stands as a sustainable method for effectively preserving and converting them into an active resource for the future, it must be supported by a thorough and multidisciplinary research in order to make informed judgments and implement appropriate solutions. The paper assesses the adaptive reuse of three historic madrasas in Istanbul and examines its impact on their preservation status. The selected madrasas are Mihrimah Sultan (1548), Şemsi Ahmed Paşa (1580), and Kılıç Ali Paşa madrasas (1588). The selected case studies are presented using data from literature, archival research, and field observations, and their adaptive reuse is evaluated using criteria established in the literature. According to the findings, adaptive reuse had a detrimental impact on the cultural significance of these valuable buildings.

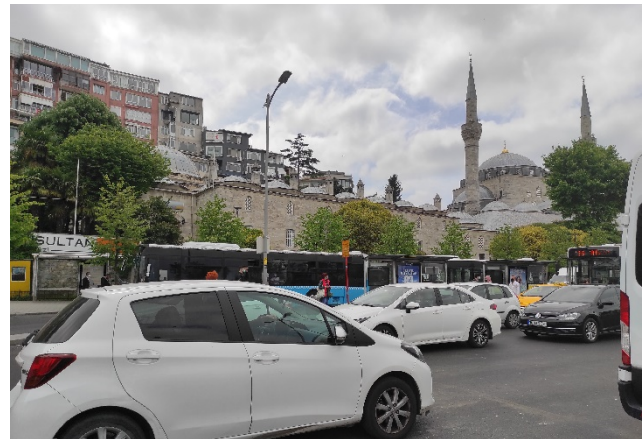
Figure 2. A general view of the madrasa from Üsküdar Pier, 2021

**Architecture:** The madrasa is a free-standing edifice with an entrance from the mosque's front portico. It has outer dimensions of 28×28.8m and a surface area of approximately 800m<sup>2</sup>. The impressive entrance portal adheres to the classical Ottoman style with its muqarnas hood and two small wall niches on either side of the arched entryway. A classroom faces the entrance, and 16 student rooms are organized symmetrically in a U-shape.

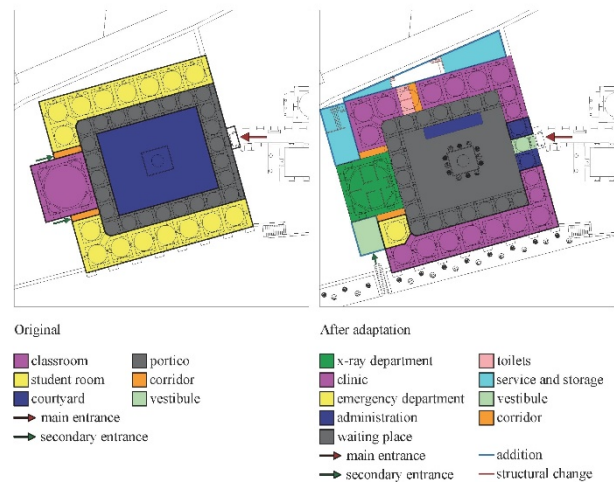
Figure 5. The functional program of the building

**Adaptive Reuse:** In addition to technical and storage services, the current program of the building includes 14 clinics, an x-ray department, an emergency department, and administrative rooms (Figure 5).

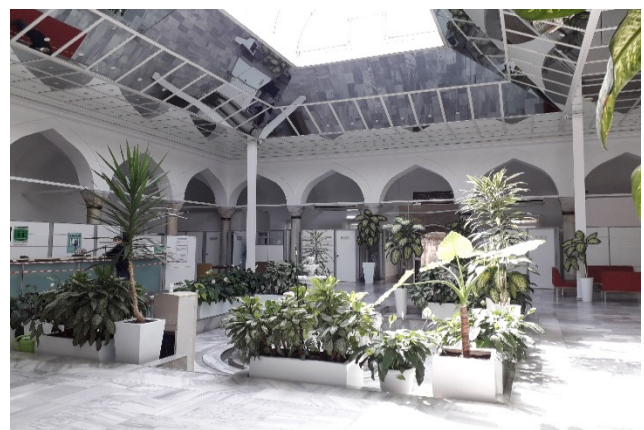
Such a heavy program necessitated wide-scope interventions in the building. The courtyard was closed off with a metal and glass roof and used to house the main information desk and waiting areas as part of the structural alterations. The character of open and semi-open areas was lost by shutting the courtyard, resulting in a confined block disconnected from nature (Figure 6).

Figure 6. A general view of the courtyard after its closure, 2021

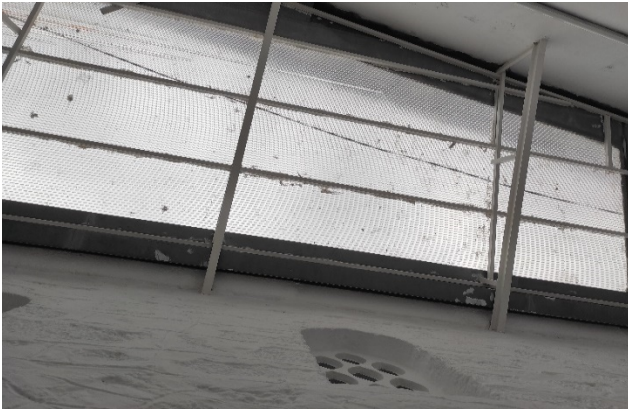
The madrasa's main entrance was reactivated, but the secondary entrance, constructed during the 1950s alterations, was retained together with its vestibule and allocated for emergency units. The space between the student rooms on the northeast and the curtain wall of the terrace was built up and set aside for storage and technical rooms (Figure 7). This part is accessible by a hallway cut in one of the student rooms. The remainder of the space was set aside for toilets. The X-ray department had reserved the classroom. A new floor was installed to divide the lofty area into two levels, and several walls separate each level into various booths. Partitions were installed in the portico bays to serve as administration rooms, clinics, or just waiting booths. All of the original building materials and architectural details, with the exception of the portico columns, have been replaced or disguised by new materials, cladding, and fittings (Figure 8).

Figure 7. A close-up view of the enclosure in the northeast showing the incompatible interventions to the madrasa's wall, 2021

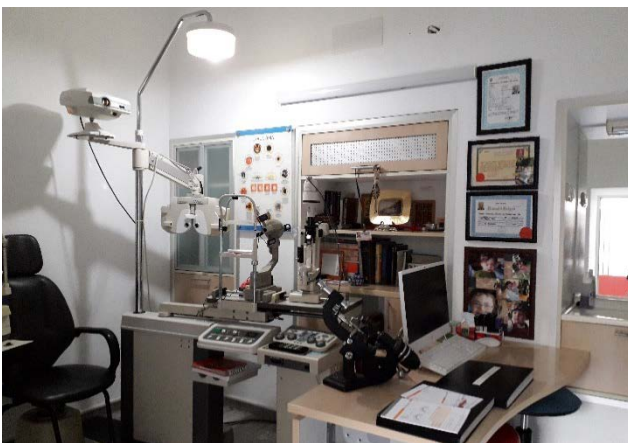
Figure 8. A general view of one of the students' rooms, 2021

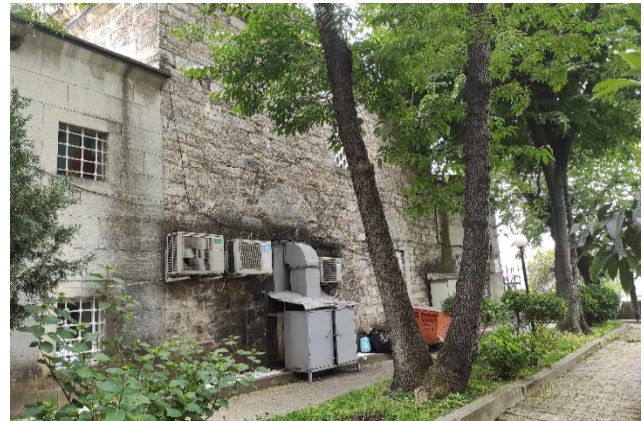
In contrast to the excessively renovated interior, the building's external characteristics have been largely preserved. However, the external surfaces show a lack of maintenance and low-quality repairs made using inappropriate materials.

It was also observed that the new fittings were installed in such a way that they harmed the historical building both visually and physically (Figure 9).

Figure 9. The external wall of the classroom showing the incompatible fittings and poor maintenance of the historic fabric, 2021

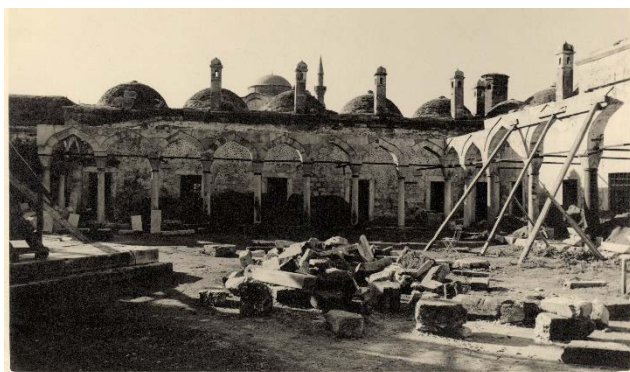
*Figure 11. A general view of the madrasa during restoration in the 1940s*

**History:** The complex was established by Şemsi Ahmed Paşa in 1580 who was a vizier and one of Sultan Murad III's favourite royal associates. It is the smallest complex designed by the chief architect Sinan and is considered one of his remarkable works as an “example of his skill in organically blending architecture with the natural landscape” [30]. The complex includes a mosque, the founder's mausoleum, and a madrasa that served as a hadith college. According to the inscription above the mosque's portal, it was completed in 1580-1581, while the first madrasa's teacher was appointed in 1572-1573 [33]. The complex was quite dilapidated by the early 20th century. The madrasa itself was out of function and its rooms were inhabited by refugees [33]. The General Directorate of Religious Endowments undertook extensive repair work in the early 1940s, which was overseen by architect Süreyya Yücel [34] (Figure 11). Despite efforts to restore the buildings in accordance with their historical characteristics, the works carried out were distant from modern restoration principles. The painted decorations and inscriptions of the mosque, for example, were significantly altered, and cement was extensively used in the madrasa [30]. In 1953, the madrasa was converted into a library, with the portico closed with glass walls and the classroom used as a reading hall [34]. Within the scope of the recent repair works in the complex, which took place in the 2010s, the madrasa was renovated with the continuation of its function as a public library.

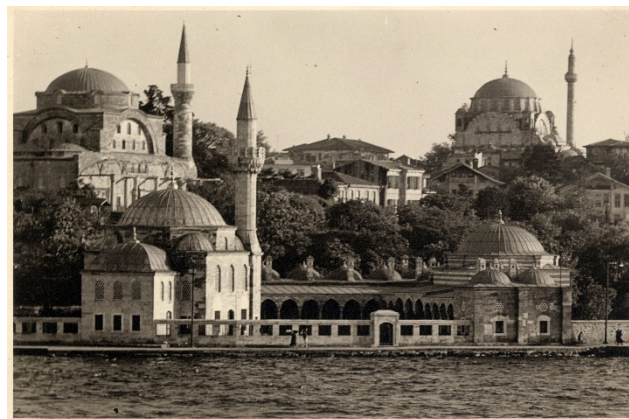
*Figure 12. A general view of the complex in the 1940s*  
*Ali Saim Ülgen Collection, Salt Research.*

The square, single-domed mosque abuts the coast at an angle, with the appending mausoleum projecting towards the waterfront. The L-shaped madrasa runs along the western and southern sides, with a sea wall on the northern side pierced with grill-windows. A small cemetery occupies the eastern side, behind the mosque (Figure 12).

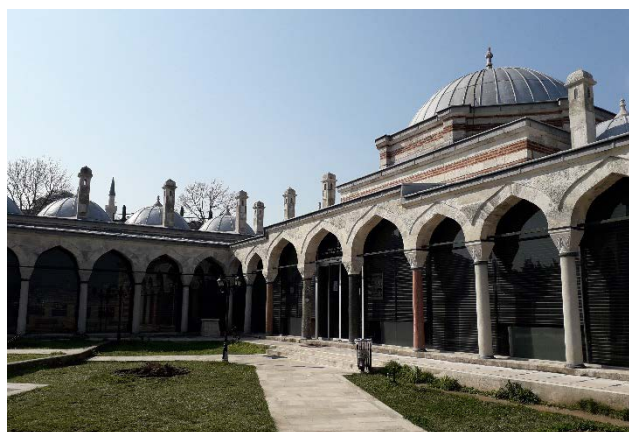
*Figure 13. A general view of the madrasa's courtyard and portico, 2021*

The madrasa consists of twelve student rooms and a large classroom. All the rooms are fronted by a portico with a shed roof and ogee arches resting on marble columns with lozenge capitals (Figure 13). The student rooms have a square plan and are covered by domes supported by pendentives. Every room features two windows, a fireplace, and one or two wall niches. The classroom is located in the midst of the western wing extending beyond the madrasa wall. It is topped with a dome carried on an octagonal drum, the windows of which alternate with four exedras. The classroom's walls have 13 windows, as well as a mihrab and two wall niches on the western wall. Finally, the restrooms are located in a vaulted cell attached to the southern wing's end.

The walls of the madrasa are built in an alternating pattern with one row of dressed stones and three rows of bricks, while the portico and seaside rooms are made with ashlar masonry to match the mosque and mausoleum on the waterfront facade. In addition, limestone was utilized for the jambs, lintels and sills of the openings. The portico features two pairs of green and pink porphyry columns aligned with the classroom's entrance. The entrance is surmounted by a depressed arch made of joggled puddingstone and limestone. The domes are constructed of brick and covered with lead.

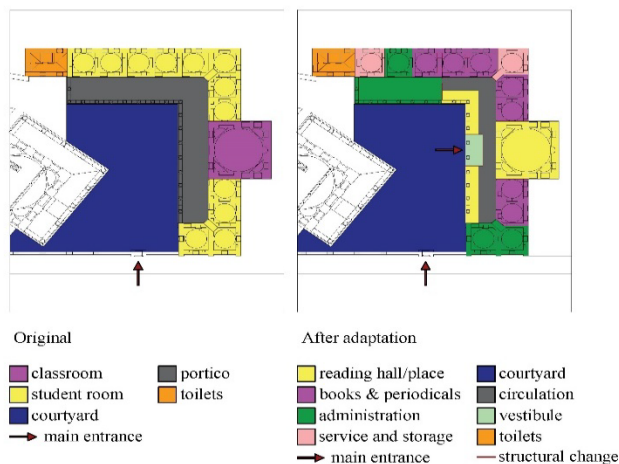
Figure 14. The functional program of the building

**Adaptive Reuse:** The madrasa's portico was encased by glass walls and supplied with an entrance right across the classroom as part of the adaptive reuse (Figure 14). The madrasa has been spatially separated from its courtyard and used entirely as a closed facility as a result of this alteration. The classroom serves as the primary reading hall, with additional reading areas located along the portico on both sides of the entry (Figure 15). Seven student rooms have been used for book shelves. Some walls were eliminated between adjacent rooms to allow for easier access (Figure 16). The remaining rooms are used for administration, storage, and a kitchenette. The restrooms have retained their original use and are accessed outdoors via the open courtyard.

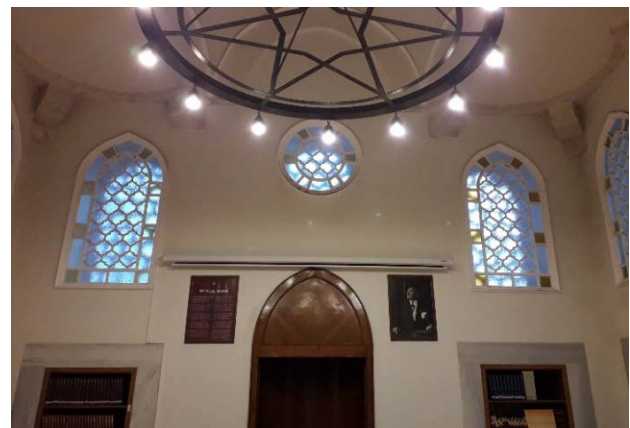
Although materials close to the originals were used in the historic building's restoration, the execution and finishing techniques demonstrate poor workmanship. On the other hand, many original elements, such as wooden doors, wooden windows, and stained glass windows, have been replaced with poor imitations (Figure 17). The external characteristics of the building are better conserved and devoid of incompatible contemporary fittings as compared to Mihrimah Sultan Madrasa. Unfortunately, this does not apply to interior.

Figure 17. A general view of the classroom showing the replaced architectural features, 2021

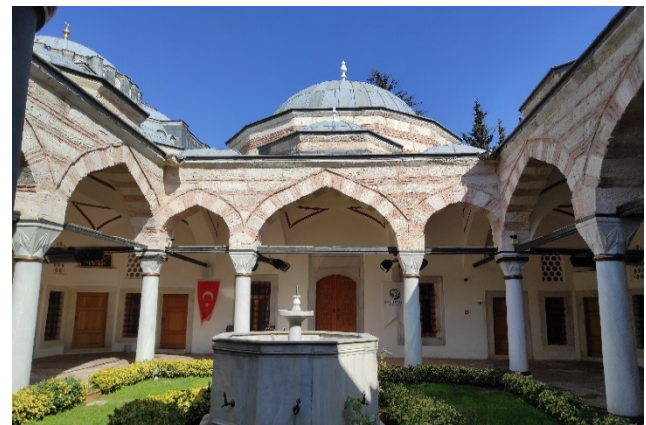
Figure 19. A general view of the courtyard, 2021

**Architecture:** The madrasa is a free-standing edifice in the complex's southern corner. The entrance is located in the north-western wing and is reached by several steps down. The classroom, seventeenth student rooms, and vestibule are positioned symmetrically along the four sides of a rectangular courtyard with an octagonal water pool in the centre (Figure 19).

The classroom is located in the midst of the north-eastern wing, projecting towards the complex's cemetery. It has a square plan and is topped by a dome supported by eight arches with squinches as transition elements. The classroom walls have seven lower and five upper windows, as well as a mihrab and three wall niches. The student rooms are also square in plan, with domes sitting on pendentives covering them. Each room has a fireplace and wall niches, as well as lower and upper windows. All of the spaces are preceded by a portico, which has a domed roof supported by ogee arches resting on marble columns with lozenge capitals. Some of the portico's bay had to be narrower in order to correspond to the axial and symmetrical design. Domical vaults rather than domes cover these bays. The walls of the madrasa are built in an alternating pattern with one row of dressed stones and three rows of brick, while the domes are made of brick and covered with lead. Marble and limestone were utilized for the jambs, lintels and sills of the openings.

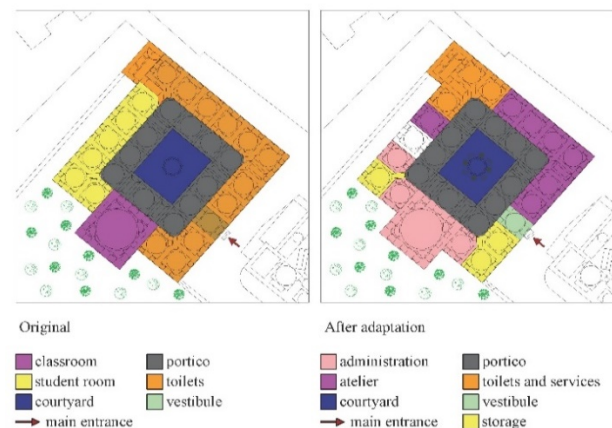
Figure 20. The functional program of the building

**Adaptive Reuse:** The building's present program includes multiple ateliers for traditional crafts in addition to administration spaces (Figure 20). The classroom serves as a meeting room (Figure 21), and eight student rooms are set aside for the various ateliers, three for administration, three for storage, and three for services.

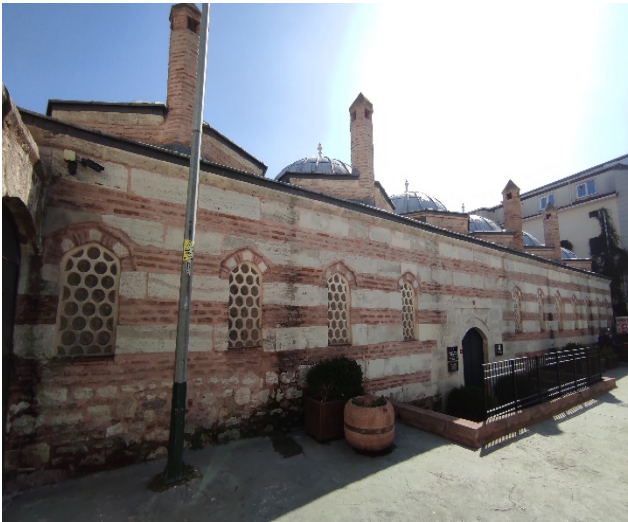
The restrooms in the southeast corner of the building were refurbished and preserved their original function. The courtyard and porticoes were maintained open, unlike the Mihrimah Sultan and Şemsi Paşa madrasas. The courtyard, however, is no longer accessible because its paved surface has been covered with a lawn.

*Figure 22. A general view of external walls showing the poor quality repairs, 2021*

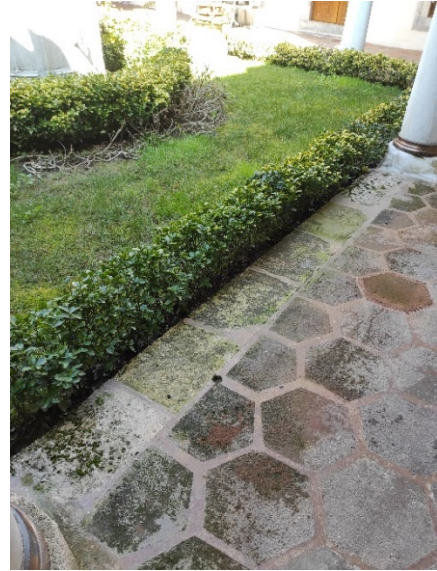
Today, the building's circulation is confined to the porticoes, which are occasionally utilized for exhibits and ceremonies. The new function of the building has not necessitated permanent structural changes, and the original features have been significantly preserved; however, the overall preservation condition of the building is critical due to poor quality repairs and restoration works (Figure 22), a lack of maintenance (Figure 23), and incompatible fittings (Figure 24).

*Figure 23. The lack of maintenance inside the building, 2021*

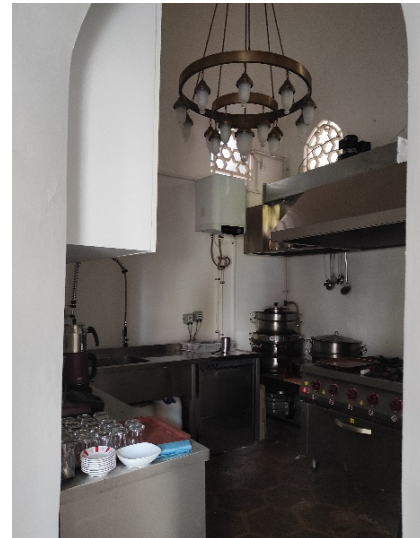
*Figure 24. A general view of one student room showing the incompatible fittings, 2021*
